# 101 E. Main St.

Inspections, Testing, and Remediation

ASBESTOS SUMMARY  
FOR  
101 MAIN STREET  
OAK HILL, WV

## ASBESTOS IDENTIFICATION BY POLARIZED LIGHT MICROSCOPY ANALYSIS

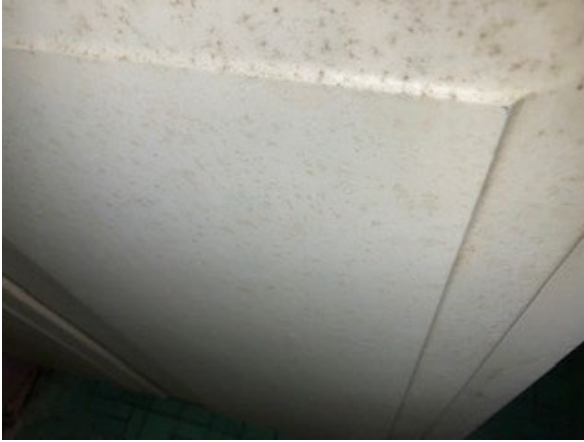
Probable mold growth on some basement hard surfaces.

Probable mold on cabinet.

Basement – Clean hard surfaces with antimicrobial solution.

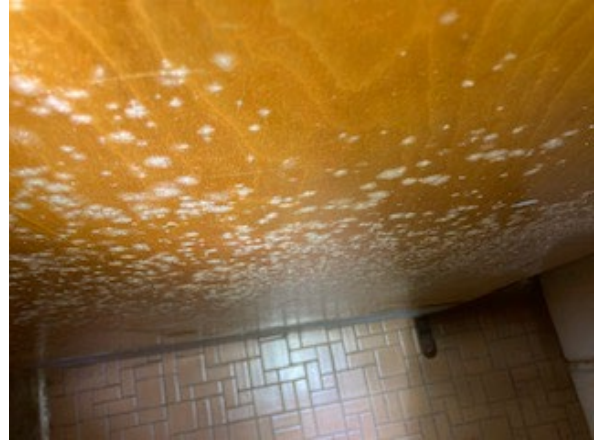
Probable mold on door.

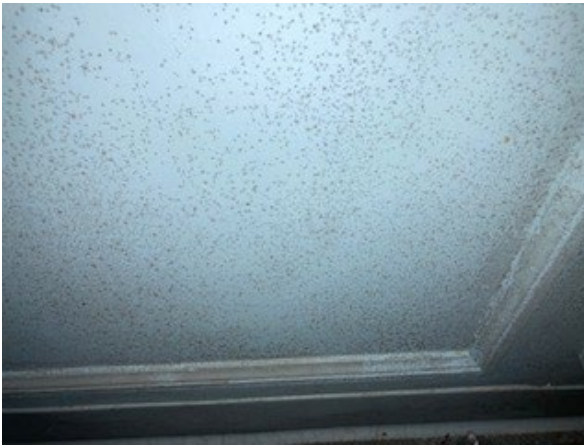
A direct swab was taken on a basement wall and lab results that cladosporium is present but not currently growing.

Probable mold on wall.

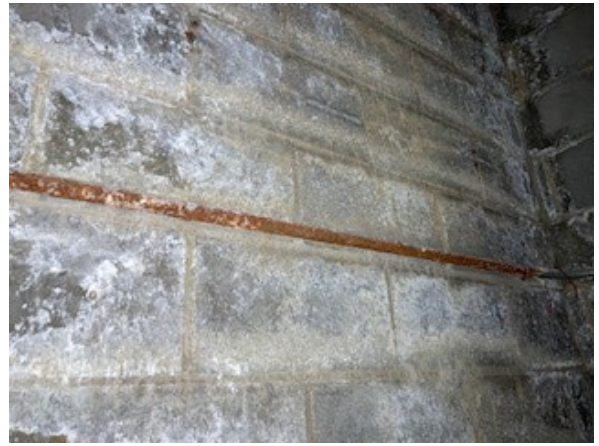
Moisture intrusion through foundation in furnace room.

Efflorescence on furnace room wall.

Install self draining dehumidifier in furnace room.

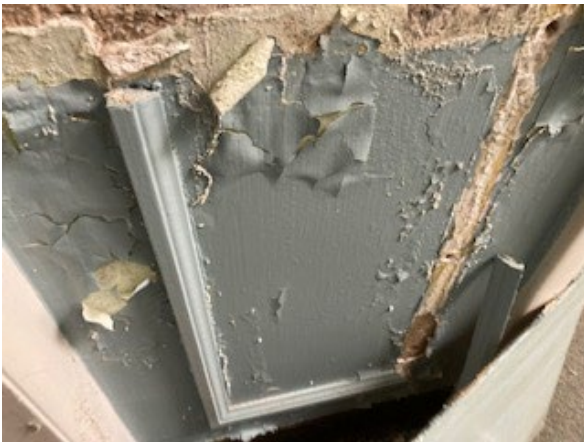
Evidence of a prior water leak near basement bathrooms.

Evidence of prior bathroom leak.
